## GIA 63W BACKSHELL CONNECTORS

PIPER AIRCRAFT, INC.  
PA-28-181, ARCHER III  
MAINTENANCE MANUAL

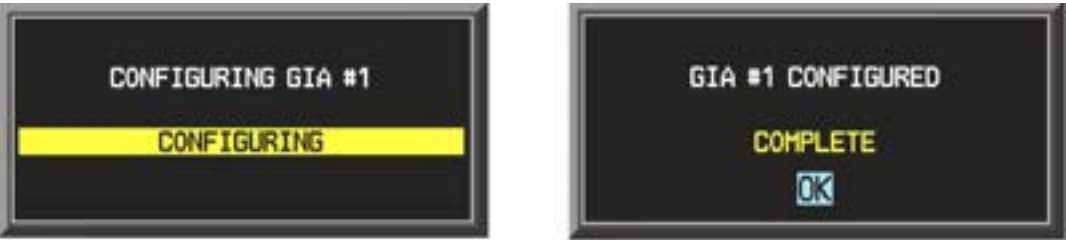
Configuration Prompts  
Figure 27

When configuration settings are changed, the technician receives on-screen prompts and/or confirmations such as those shown in "Figure 27". Other prompts may be encountered during the configuration process.

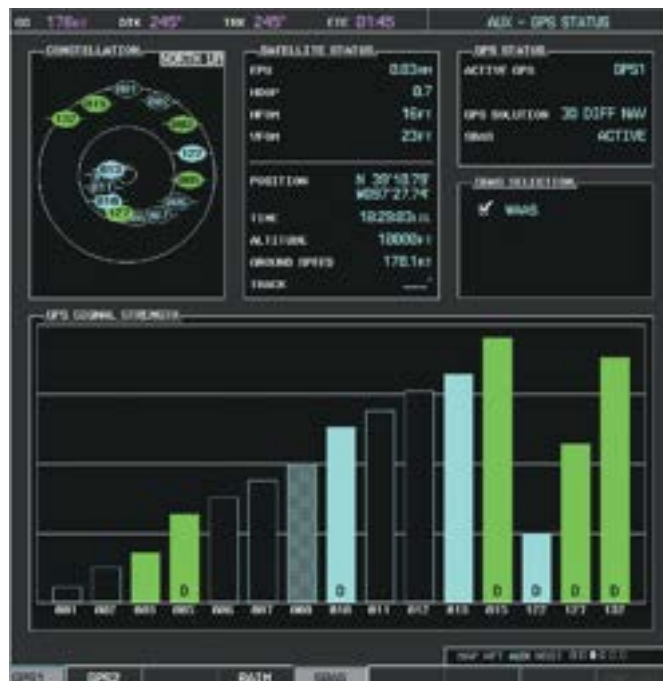
GPS STATUS Page (MFD)  
Figure 34

- 1) Select the GPS STATUS page on the MFD (fourth page in AUX group).
- 2) Two softkeys on the bottom of the display will toggle between GPS1 and GPS2.
- 3) Verify that both receivers show 3D DIFF NAV on the MFD.

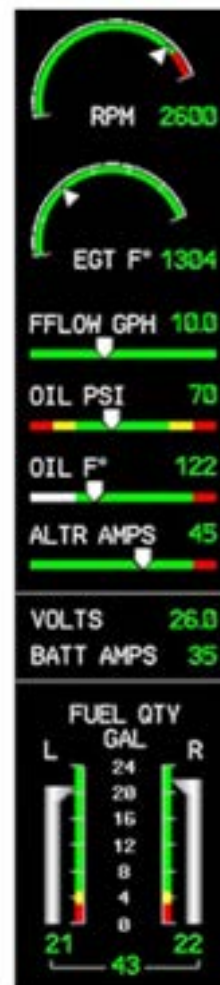
Normal Engine Instruments  
Figure 35

- (a) On the MFD (Normal Mode), check the indication for each of the sensor or monitor inputs with the aircraft engines off. In general, verify all engine and system instruments show valid static normal values and markings, with no red Xs or erratic indications. Refer to "Figure 35" (baseline configuration instruments shown) for normal engine instrument markings.
- (b) If no other service is to be performed, continue to the Return to Service Procedure, below.

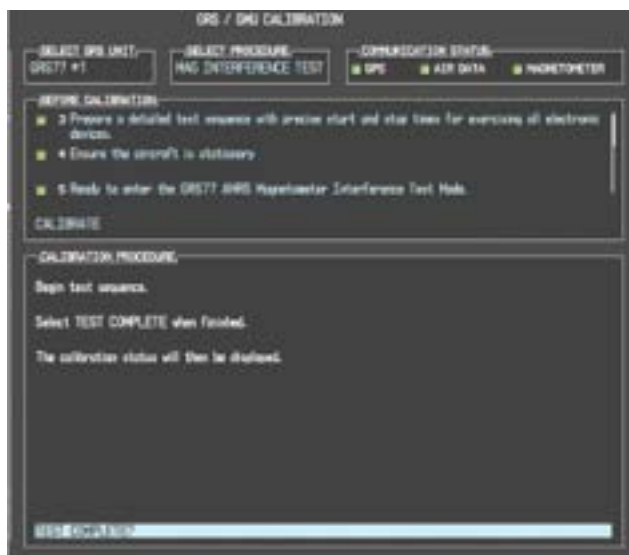
Magnetometer Interference Test  
Figure 36

- (a) Start the PFD and MFD in Configuration Mode by holding ENT on each display while closing the circuit breaker.
- (b) Go to the GRS Page Group on the PFD by rotating the large FMS knob.
- (c) Select the GRS/GMU Calibration Page, as shown in "Figure 36". This page is protected and requires a keystroke password to perform this test. Press the following softkeys in sequence:
  - 9
  - 10
  - 11
  - 12 (far right softkey)
- (d) Press the ENT key.
- (e) Select MAG INTERFERENCE TEST and press the ENT key.
- (f) Follow the checklist items displayed on the PFD, and press the ENT key as each one is completed or confirmed.

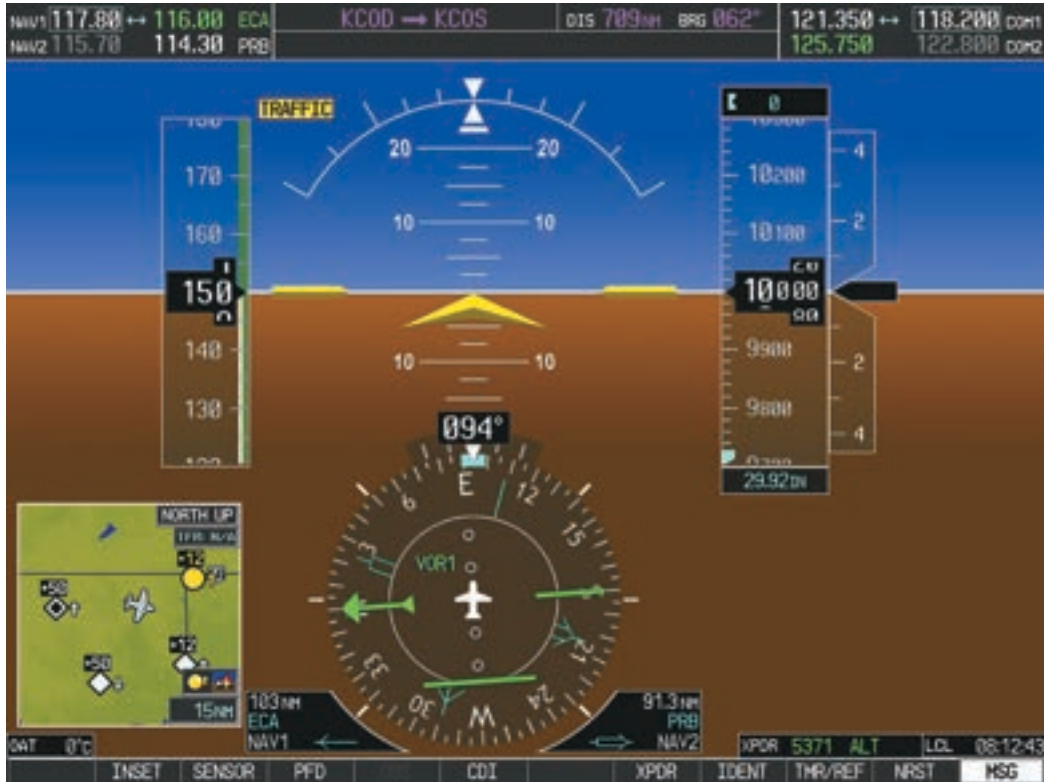
Normal Mode AHRS Check  
Figure 37

The aircraft may now be taxied back and the engine can be shut down for final testing. Restart the displays in Normal Mode to conduct final system checks. When the PFD powers up in Normal Mode, the AHRS attitude and heading information displayed should become valid within one (1) minute of power-up, as shown in "Figure 37" (provided both GPS receivers have a valid position; if GPS is unavailable, AHRS initialization may take as long as two (2) minutes).

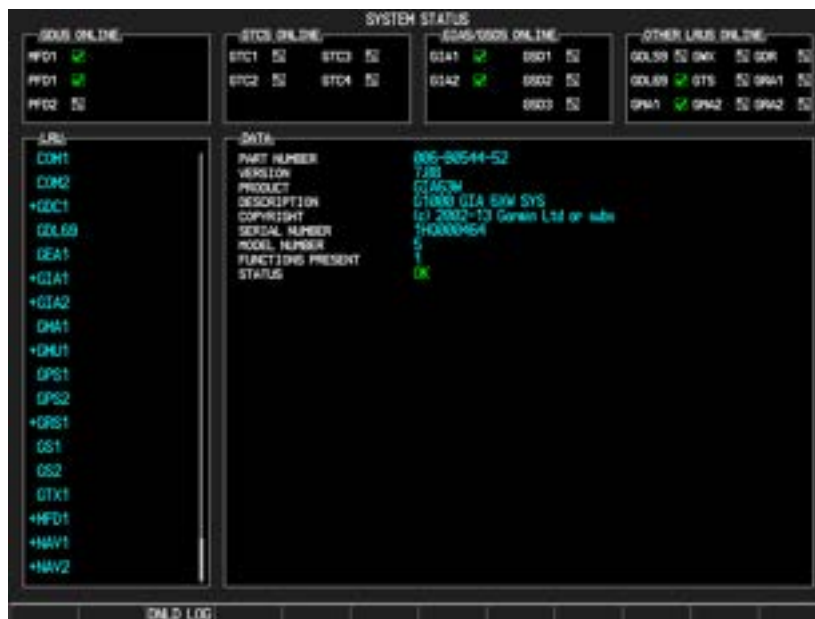
Figure 38

- (a) The PFD System Status page (see "Figure 38") displays a list of LRUs in the LRU window.
- (b) Enter Configuration Mode on the PFD and MFD by applying power while holding ENT.
- (c) Verify on the System Configuration Page that the following are valid (indicated by green annunciations): MFD1, PFD, GIA1, GIA2, and GDL 69A (optional).
- (d) Verify on the System Status Page that the following are valid (green annunciations indicate that the system is healthy): MFD1, PFD, GIA1, GIA2, and GDL 69A (optional).

System Status Page (Configuration Mode)

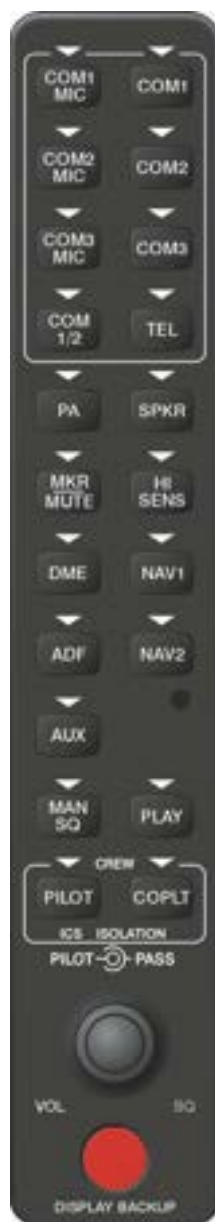
Audio Control and Display Backup (GMA 1347)  
Figure 6

Both displays may be set to reversionary mode at any time by pressing DISPLAY BACKUP on the GMU 1347 (see "Figure 6").

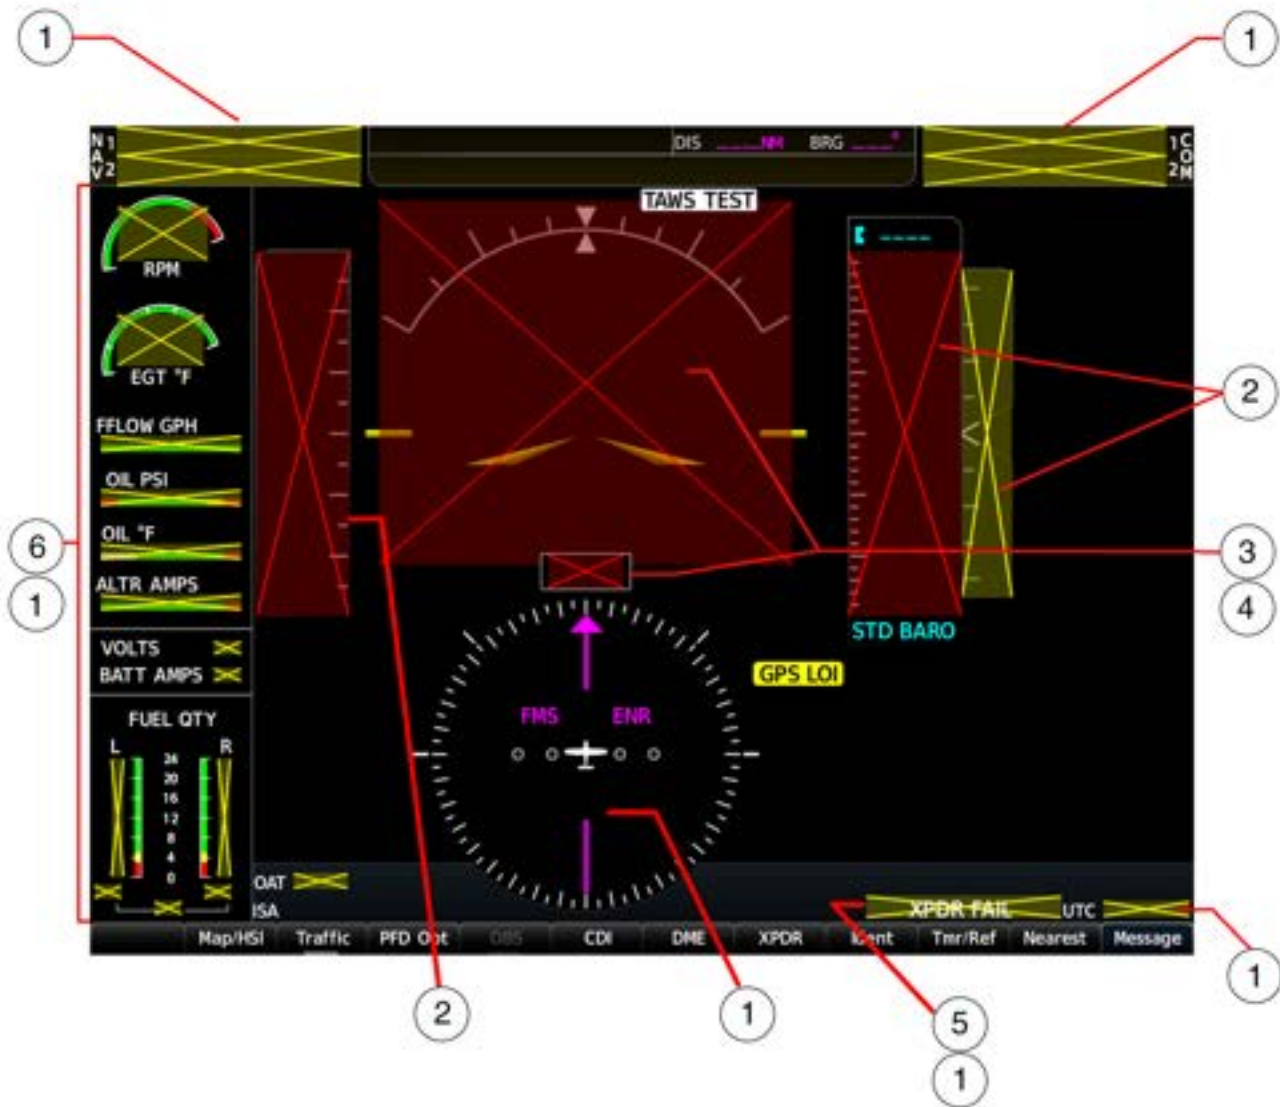
System Fail  
Figure 8

1. GIA 63W Integrated Avionics Units
2. GSU 75 ADAHRS
3. GSU 75 ADAHRS
4. GMU 44 Magnetometer
5. GTX 3X5R Transponder
6. GEA 71 Engine Airframe Units

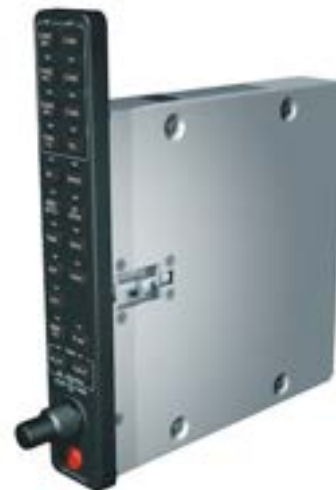
GMA 1347 Audio Panel  
Figure 10

- 1) Visually inspect the connectors using a flashlight to ensure there are no bent or damaged pins. Repair any damage.
- 2) Gently insert the GMA 1347 into the rack until the locking tab engages the rack.
- 3) Turn the hex nut clockwise to draw unit into rack until seated. Do not overtighten nut.
- 4) Connect the negative (ground) battery cable.

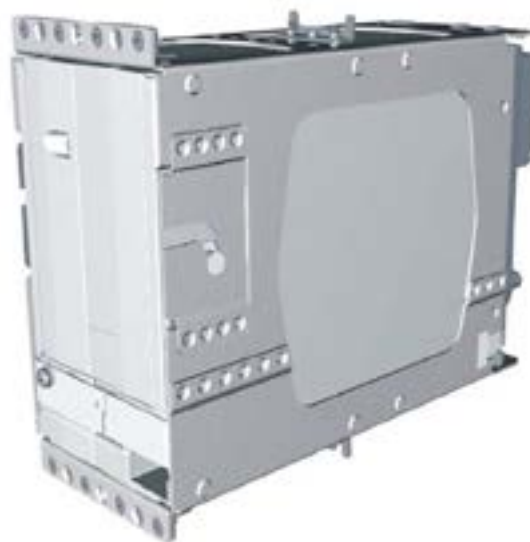
GIA 63W Integrated Avionics Unit  
Figure 11

Two Garmin GIA 63W Integrated Avionics Units (IAUs) contain the VHF COM/NAV receivers, WAAS GPS receiver, Flight Director, and system integration microprocessors. The GIAs also serve as a communication interface to all other G1000 NXi LRUs in the system. Each GIA 63W communicates directly with the on-side GDU 105X display using a HSDB Ethernet connection. Both GIAs are located directly behind the PFD and MFD, installed into their respective LRU racks. Power is provided to GIA1 by the essential bus or the emergency bus. GIA2 is powered by the avionics bus.

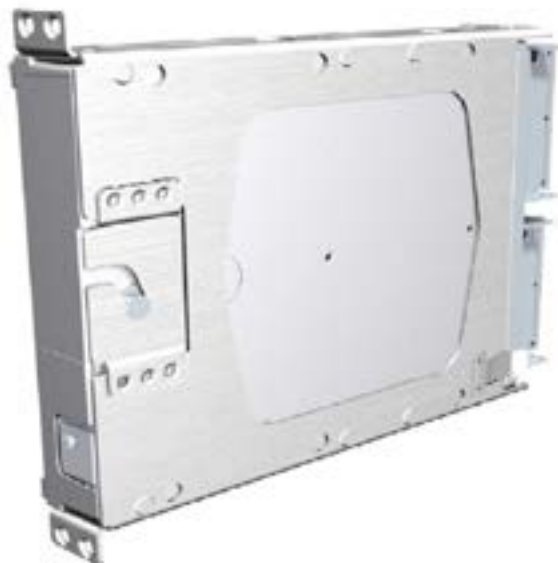
GEA 71 Engine/Airframe Unit  
Figure 12

- 1) Visually inspect the connectors to ensure there are no bent or damaged pins. Repair any damage.
- 2) Gently insert the GEA 71 into the rack. The handle should engage the dogleg track.
- 3) Press down on the handle to lock the unit into place.
- 4) Lock the handle to the GEA 71 body using the Phillips screw.
- 5) Reinstall the MFD as described above.

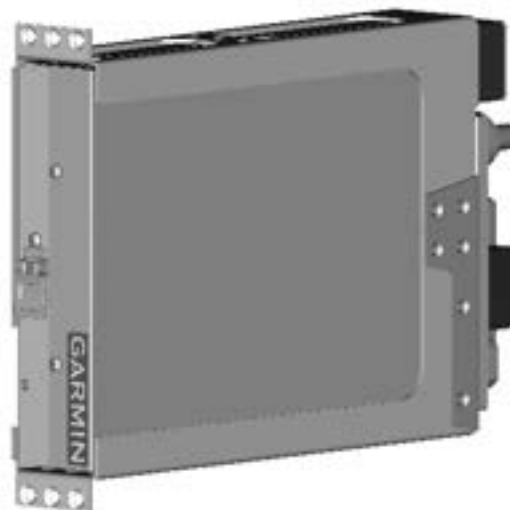
GTX 3X5R Mode S/ES Transponder  
Figure 14

- 1) Visually inspect the connectors to ensure there are no bent or damaged pins. Repair any damage.
- 2) Gently insert the GTX 3X5R into its rack, pressing it back until the front of the unit is flush with the aft edge of the rack.
- 3) Insert a 3/32 inch hex driver into the hole along the left edge of the lower half of the unit.

See "Figure 14".

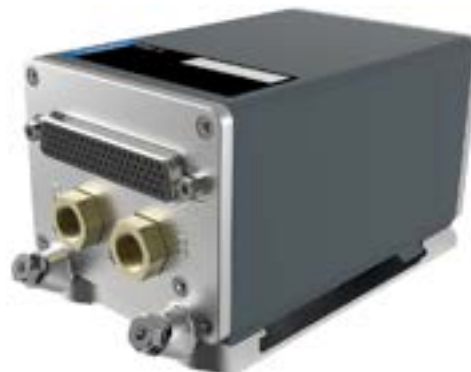
GSU 75 ADAHRS  
Figure 15

The GSU 75 is mounted on top of a bracket at the left side of the airplane just forward of F.S. 191.00. Power is provided to the unit from the essential bus or the emergency bus. The GSU 75 provides power to the GMU 44 and GTP 59.

The Garmin GSU 75 ADAHRS provides flight altitude, airspeed, attitude and heading data for flight instrumentation to the G1000 NXi system. It contains advanced tilt sensors, accelerometers, and rate sensors. The unit interfaces with the GMU44 Magnetometer and GTP 59 OAT Probe. It receives GPS signals from the GIA 63Ws. Actual attitude and heading information is sent using ARINC 429 digital interface to both GDU 105Xs (PFD and MFD) and the GIA 63Ws.

- (8) GSU 75 Air Data and Attitude and Heading Reference System (ADAHRS)  
See "Figure 15".

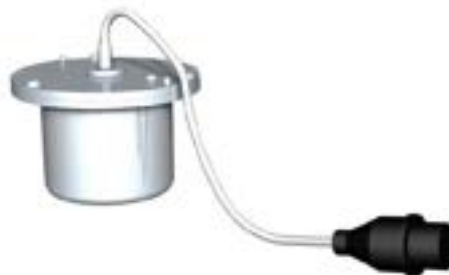
GMU 44 Magnetometer  
Figure 17

The GMU 44 provides horizontal and vertical magnetic field information to the GSU 75 ARHS. This LRU is powered via the GSU 75. It communicates with the GSU 75 using a RS-485 digital interface. The GMU 44 bracket is mounted on a wing access cover assembly at the bottom of the left wing between WS 148.60 and 131.60.

- 1) Visually inspect the connectors to ensure there are no bent or damaged pins. Repair any damage.
- 2) Place the GMU 44 into its mounting bracket, make sure the arrow on the GMU44 aligns with the arrow on the mounting bracket, and secure three non-ferrous screws. Torque 12-15 in-lbs. Connect the grounding strap.
- 3) Reconnect the GMU 44 pigtail to the wing wiring harness.
- 4) Reinstall the magnetometer cover assembly, make sure the arrow on the GMU44 is pointing forward, and secure the assembly with eight (8) non-ferrous screws.
- 5) Connect the negative (ground) battery cable.

See "Figure 17".

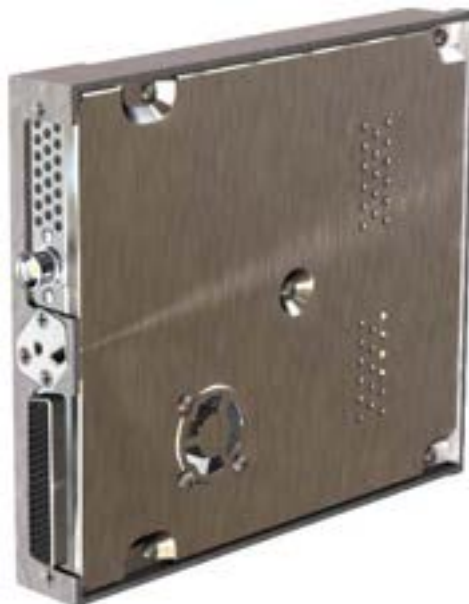
GDL 59 Data Link Unit  
Figure 18

The GDL 59 is located just forward of F.S. 191.00. It's mounted in an equipment rack attached to the inboard side of a bracket at the left side of the airplane. The associated Wi-Fi antenna is mounted atop the tailcone under the dorsal fairing (see Figure 1 in 23-00-00).

The GDL 59 is a flight parameter recorder with a high-speed Wi-Fi transceiver for transmitting collected data from the airplane to a Wi-Fi hotspot for trend monitoring and maintenance planning. In flight, the unit records specified data from the G1000 NXi system. Such data can include engine trend and exceedance data, system maintenance data, crew advisory system (CAS) messages and more. Up to two gigabytes of memory is available to support hours of flight time logging. On the ground, logged data / reports can be sent through the integrated 802.11g Wi-Fi transceiver. Simply park the airplane within range of a Wi-Fi hotspot and use the MFD to select data to upload.

- 1) Visually inspect the connector to ensure there are no bent or damaged pins. Repair any damage.
- 2) Position the unit in the rack with the installation lever raised and slide aft until the installation lever engages its slot in the rack.
- 3) Press the installation lever down to fully seat the unit. Secure with Phillips head screw, torquing 10–14 in-lbs.
- 4) Install the baggage compartment rear closeout panel.
- 5) Connect the negative (ground) battery cable.

See "Figure 18".

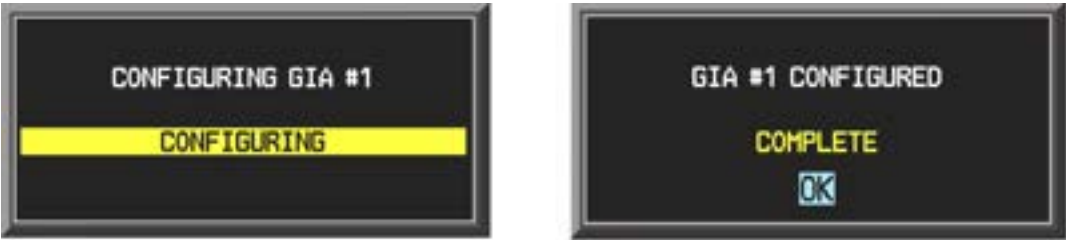
Configuration Prompts  
Figure 28

When configuration settings are changed, the technician receives on-screen prompts and/or confirmations such as those shown in "Figure 28". Other prompts may be encountered during the configuration process.

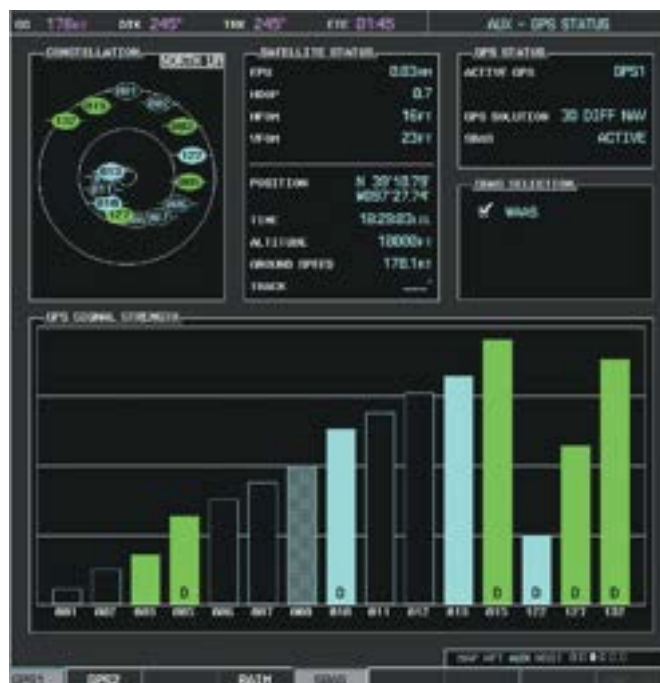
GPS STATUS Page (MFD)  
Figure 35

(a) GPS Signal Acquisition (see "Figure 35")

- 1) Select the GPS STATUS page on the MFD (fourth page in AUX group).
- 2) Two softkeys on the bottom of the display will toggle between GPS1 and GPS2.
- 3) Verify that both receivers show 3D DIFF NAV on the MFD.

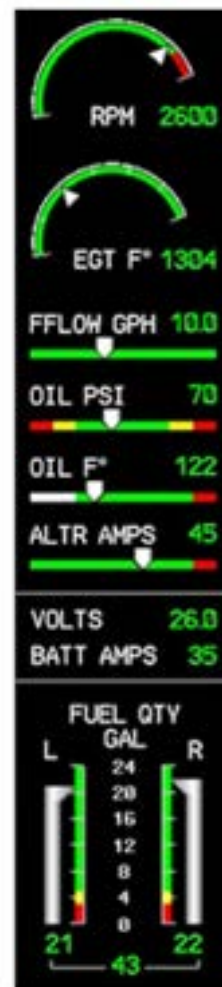
Normal Engine Instruments  
Figure 36

- (a) On the MFD (Normal Mode), check the indication for each of the sensor or monitor inputs with the aircraft engines off. In general, verify all engine and system instruments show valid static normal values and markings, with no red Xs or erratic indications. Refer to "Figure 36" (baseline configuration instruments shown) for normal engine instrument markings.
- (b) If no other service is to be performed, continue to the Return to Service Procedure, below.

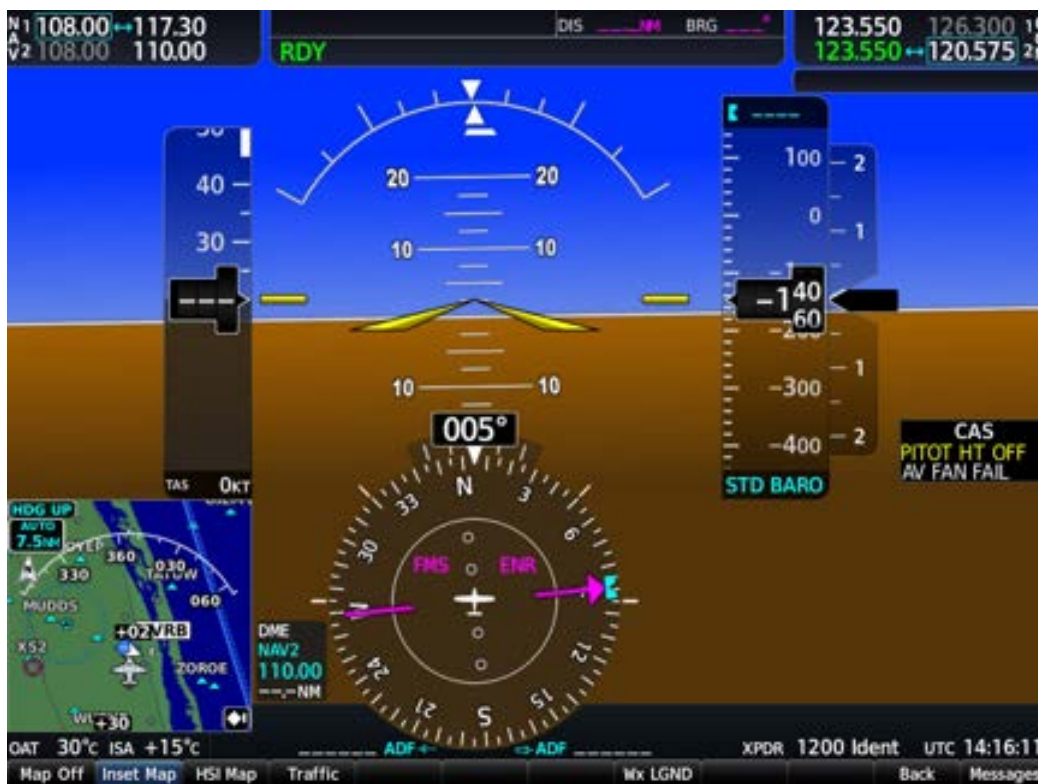
ADAHRS Normal Mode Check  
Figure 38

The aircraft may now be taxied back and the engine can be shut down for final testing. Restart the displays in Normal Mode to conduct final system checks. When the PFD powers up in Normal Mode, the ADAHRS attitude and heading information displayed should become valid within one (1) minute of power-up, as shown in "Figure 38" (provided both GPS receivers have a valid position; if GPS is unavailable, ADAHRS initialization may take as long as two (2) minutes).

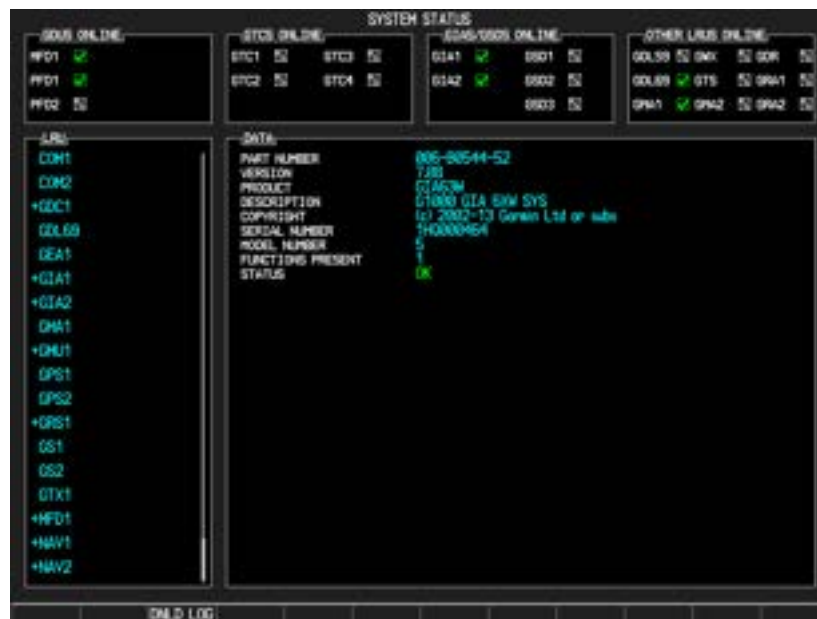
System Status Page (Configuration Mode)  
Figure 40

- (a) The PFD System Status page (see "Figure 40" on page 342502137) displays a list of LRUs in the LRU window.
- (b) Enter Configuration Mode on the PFD and MFD by applying power while holding ENT.
- (c) Verify on the System Configuration Page that the following are valid (indicated by green annunciations): MFD, PFD, GIA1, GIA2, and GDL 69eA (optional).
- (d) Verify on the System Status Page that the following are valid (green annunciations indicate that the system is healthy): MFD, PFD, GIA1, GIA2, and GDL 69eA (optional).

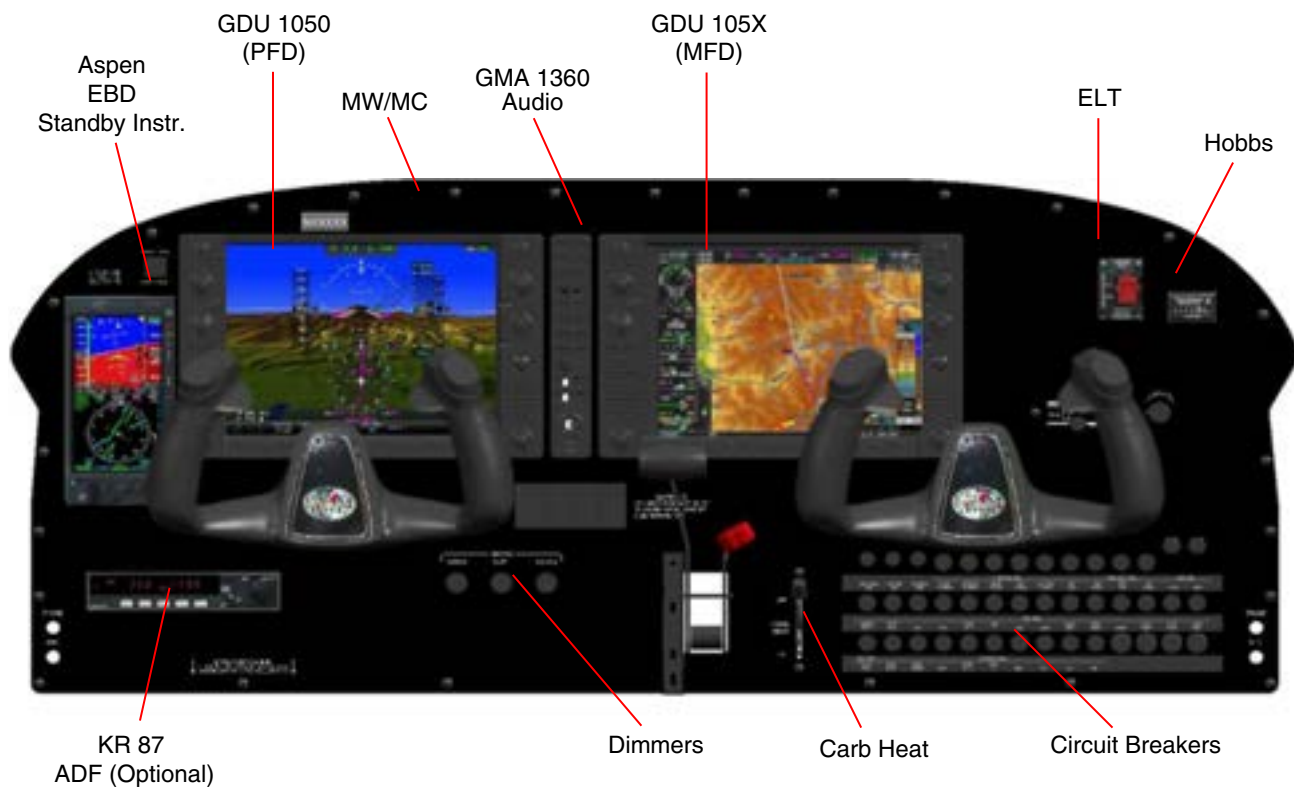
Garmin G1000 NXi Instrument Panel  
Figure 1 (Sheet 1 of 2)

Detailed descriptions of the individual G1000 NXi system components/Line Replaceable Units (LRU's) are found below.

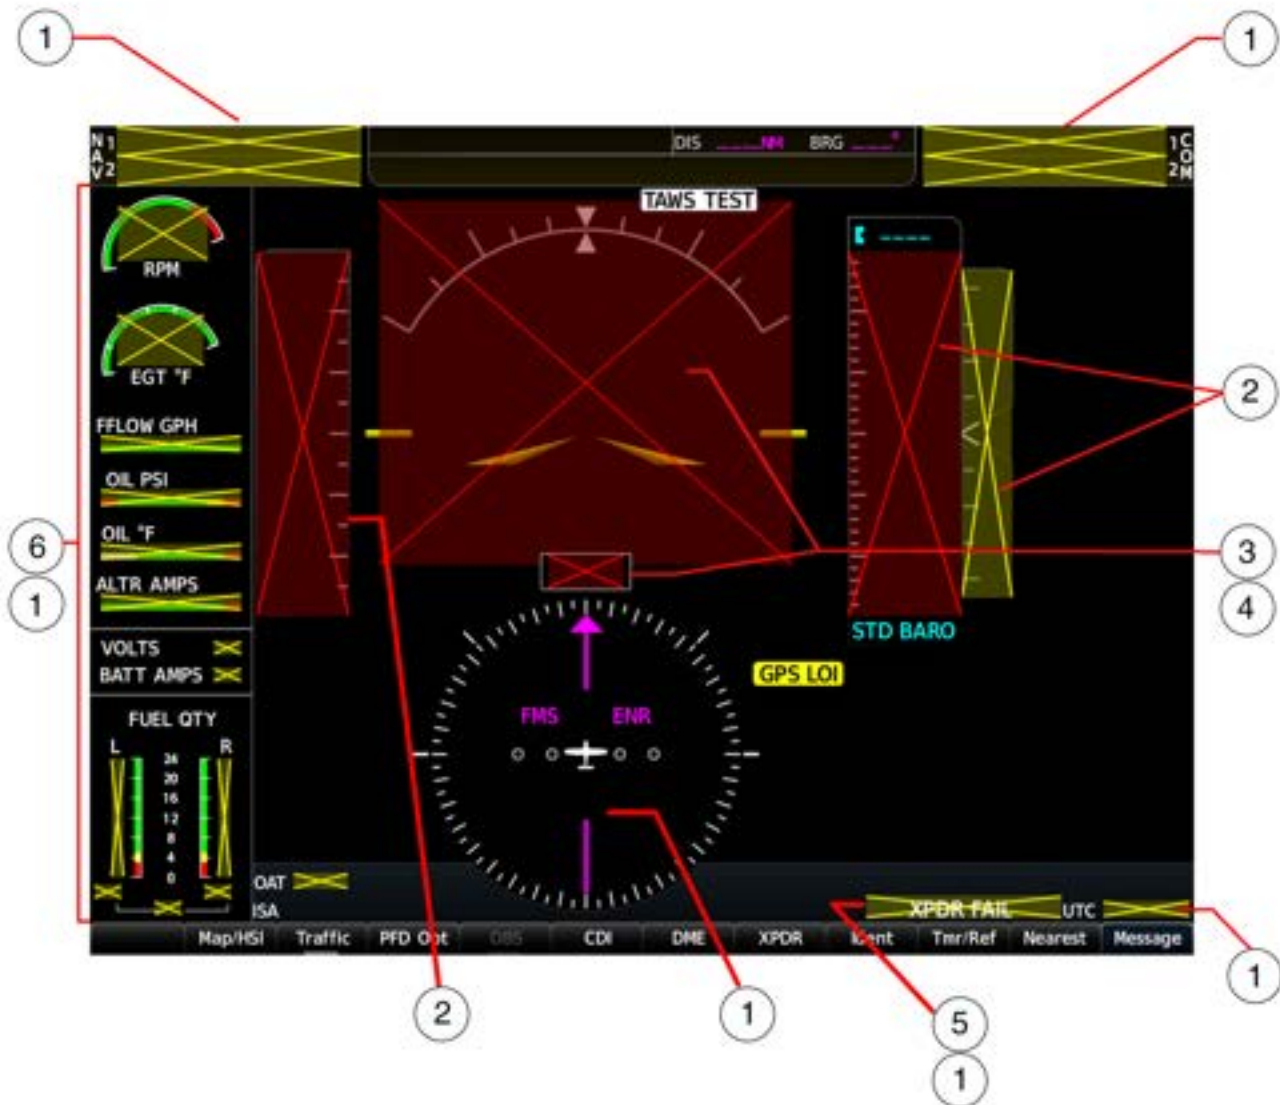
System Fail  
Figure 8

1. GIA 64/64W Integrated Avionics Units
2. GSU 75 ADAHRS
3. GSU 75 ADAHRS
4. GMU 44/44B Magnetometer
5. GTX 3X5R Transponder
6. GEA 71B Engine Airframe Interface

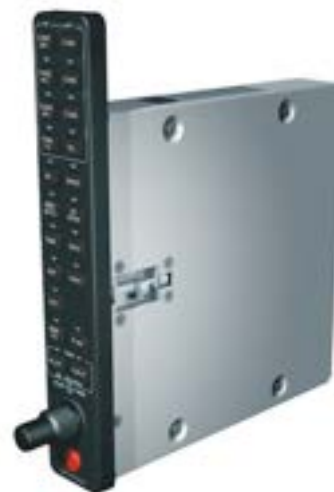
GMA 1360 Audio Panel  
Figure 10

- 1) Visually inspect the connectors using a flashlight to ensure there are no bent or damaged pins. Repair any damage.
- 2) Gently insert the GMA 1360 into the rack until the locking tab engages the rack.
- 3) Turn the hex nut clockwise to draw unit into rack until seated. Do not overtighten nut.
- 4) Connect the negative (ground) battery cable.

See "Figure 10".

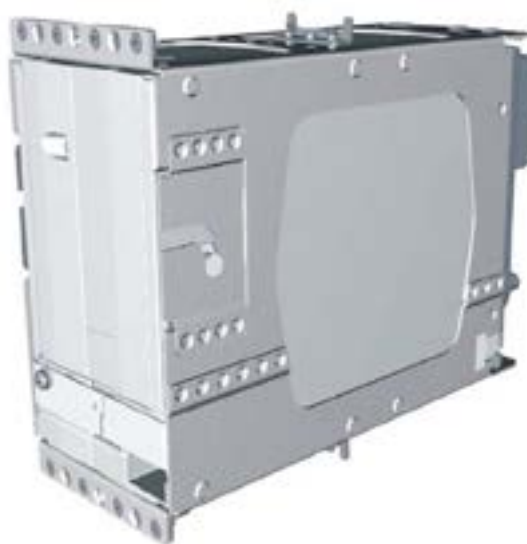
GIA 64 Integrated Avionics Unit  
Figure 11

Two Garmin GIA 64/64W Integrated Avionics Units (IAUs) contain the VHF COM/NAV receivers, WAAS GPS receiver, Flight Director, and system integration microprocessors. The GIAs also serve as a communication interface to all other G1000 NXi LRUs in the system. Each GIA 64/64W communicates directly with the on-side GDU 105x display +using a HSDB Ethernet connection. Both GIAs are located directly behind the PFD and MFD, installed into their respective LRU racks. Power is provided to GIA1 by the essential bus or the emergency bus. GIA2 is powered by the avionics bus.

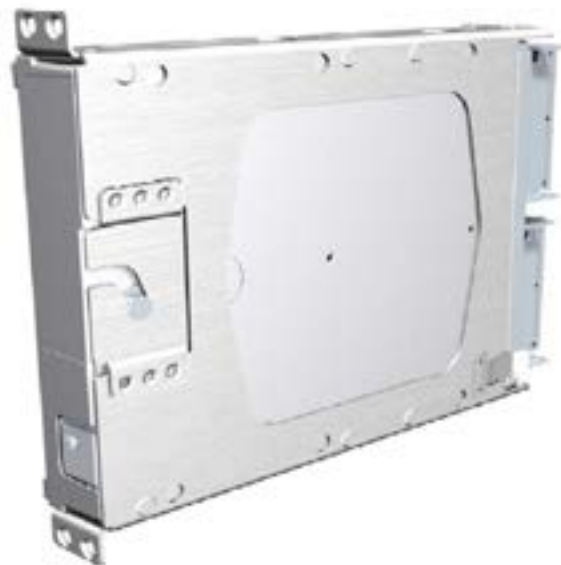
GEA 71B Engine/Airframe Unit  
Figure 12

- 1) Visually inspect the connectors to ensure there are no bent or damaged pins. Repair any damage.
- 2) Gently insert the GEA 71B into the rack. The handle should engage the dogleg track.
- 3) Press down on the handle to lock the unit into place.
- 4) Lock the handle to the GEA 71B body using the Phillips screw.
- 5) Reinstall the MFD as described above.

See "Figure 12".

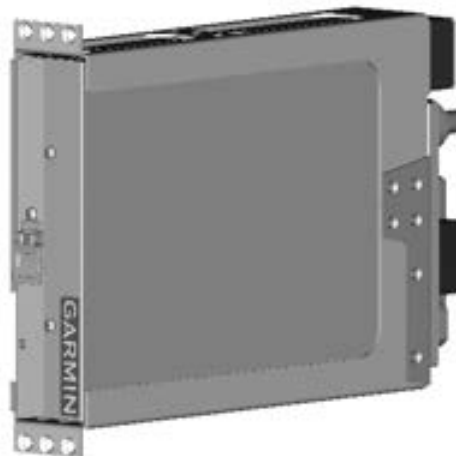
GTX 3X5R Mode S/ES Transponder  
Figure 14

- 1) Visually inspect the connectors to ensure there are no bent or damaged pins. Repair any damage.
- 2) Gently insert the GTX 3X5R into its rack, pressing it back until the front of the unit is flush with the aft edge of the rack.
- 3) Insert a 3/32 inch hex driver into the hole along the left edge of the lower half of the unit.

See "Figure 14".

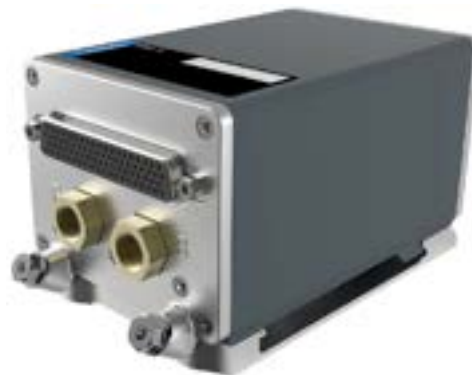
GSU 75 ADAHRS  
Figure 15

The GSU 75 is mounted on top of a bracket at the left side of the airplane just forward of F.S. 191.00. Power is provided to the unit from the essential bus or the emergency bus. The GSU 75 provides power to the GMU 44/44B and GTP 59.

The Garmin GSU 75 ADAHRS provides flight altitude, airspeed, attitude and heading data for flight instrumentation to the G1000 NXi system. It contains advanced tilt sensors, accelerometers, and rate sensors. The unit interfaces with the GMU44/44B Magnetometer and GTP 59 OAT Probe. It receives GPS signals from the GIA 63Ws. Actual attitude and heading information is sent using ARINC 429 digital interface to both GDU 105xs (PFD and MFD) and the GIA 64/64Ws.

- (8) GSU 75 Air Data and Attitude and Heading Reference System (ADAHRS)  
See "Figure 15".

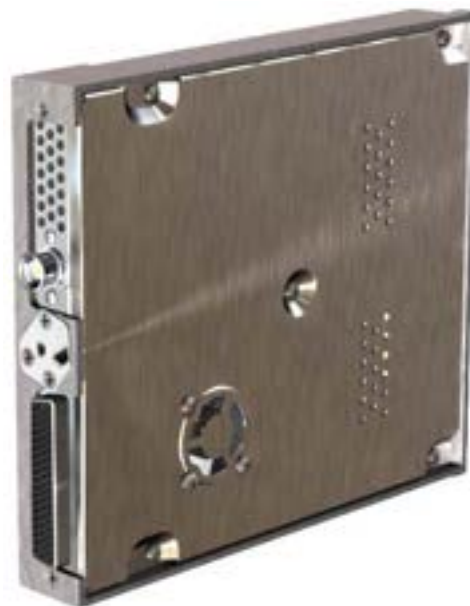
GDL 59 Data Link Unit  
Figure 18

The GDL 59 is located just forward of F.S. 191.00. It's mounted in an equipment rack attached to the inboard side of a bracket at the left side of the airplane. The associated Wi-Fi antenna is mounted atop the tailcone under the dorsal fairing (see Figure 1 in 23-00-00).

The GDL 59 is a flight parameter recorder with a high-speed Wi-Fi transceiver for transmitting collected data from the airplane to a Wi-Fi hotspot for trend monitoring and maintenance planning. In flight, the unit records specified data from the G1000 NXi system. Such data can include engine trend and exceedance data, system maintenance data, crew advisory system (CAS) messages and more. Up to two gigabytes of memory is available to support hours of flight time logging. On the ground, logged data / reports can be sent through the integrated 802.11g Wi-Fi transceiver. Simply park the airplane within range of a Wi-Fi hotspot and use the MFD to select data to upload.

See "Figure 18".

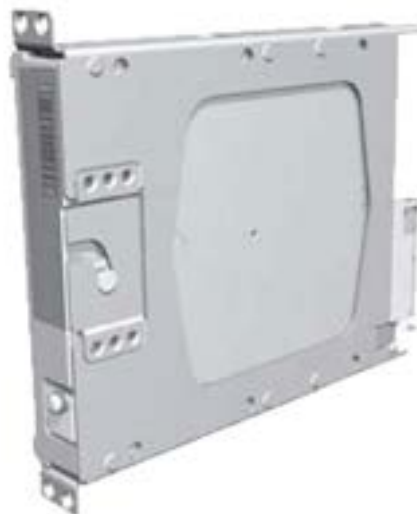
GDL 69A/69eA Data Link Unit  
Figure 19

No software or configuration loading is required if the original GDL 69 is reinstalled. This does not include units that were returned for repair as their software and configuration files are deleted during the repair testing process. Continue to the "GDL 69 SXM Test" on page 342503130 under LRU Test Procedures.

See "Figure 19".

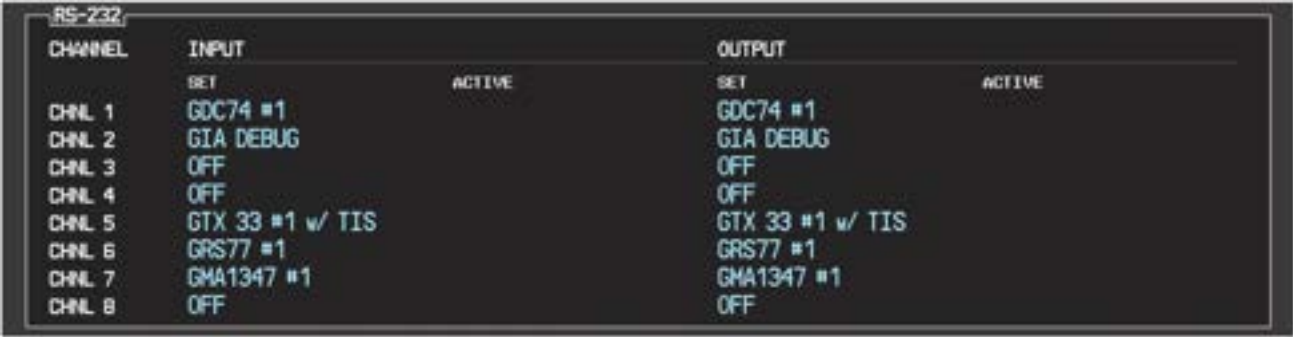
Set > Active - Loss of Communications  
Figure 27

A blank active column, as shown in "Figure 27", represents loss of communication between the display and the particular unit. See troubleshooting for more details.

When troubleshooting the system, technicians can look for inequalities between SET and ACTIVE columns. Certain problems can be resolved simply by pressing the SET>ACTV softkey, which reloads settings to the specific LRU from the PFD (Note that this can also be accomplished by reloading the configuration files for the LRU, using the software loader card.).

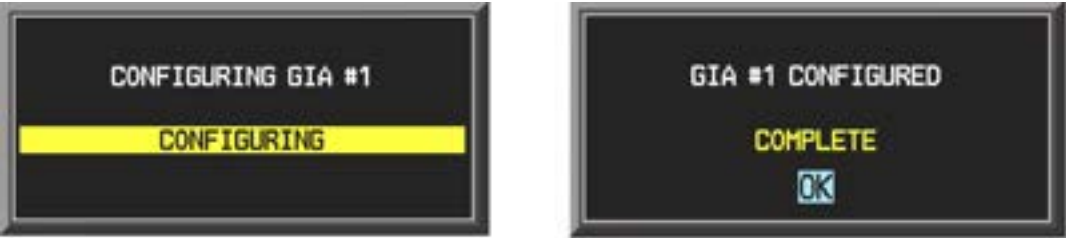
Configuration Prompts  
Figure 28

When configuration settings are changed, the technician receives on-screen prompts and/or confirmations such as those shown in "Figure 28". Other prompts may be encountered during the configuration process.

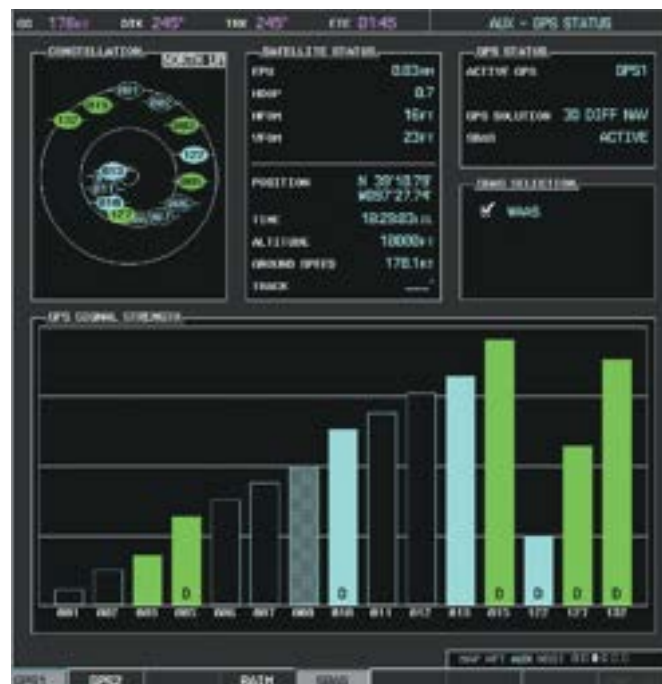
GPS STATUS Page (MFD)  
Figure 35

(a) GPS Signal Acquisition (see "Figure 35")

- 1) Select the GPS STATUS page on the MFD (fourth page in AUX group).
- 2) Two softkeys on the bottom of the display will toggle between GPS1 and GPS2.
- 3) Verify that both receivers show 3D DIFF NAV on the MFD.

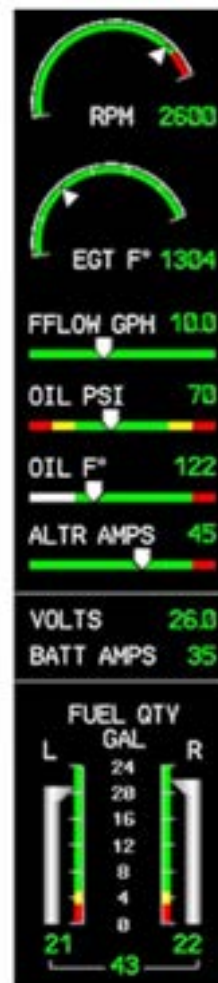
Normal Engine Instruments  
Figure 36

- 6) Perform GS 1 and GS 2 accuracy tests: Full scale, Half scale.
  - 7) Check GS 1 and GS 2 Sensitivity.
- (5) GEA 71B Test
  - (a) On the MFD (Normal Mode), check the indication for each of the sensor or monitor inputs with the aircraft engines off. In general, verify all engine and system instruments show valid static normal values and markings, with no red Xs or erratic indications. Refer to "Figure 36" (baseline configuration instruments shown) for normal engine instrument markings.

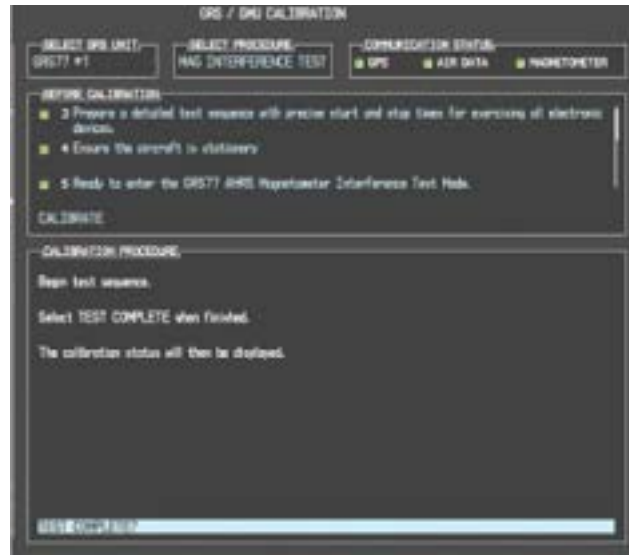
Magnetometer Interference Test  
Figure 37

- (a) Start the PFD and MFD in Configuration Mode by holding ENT on each display while closing the circuit breaker.
- (b) Go to the GSU Page Group on the PFD by rotating the large FMS knob.
- (c) Select the GSU/GMU Calibration Page, as shown in "Figure 37" on page 342503128. This page is protected and requires a keystroke password to perform this test. Press the following softkeys in sequence:
  - 9
  - 10
  - 11
  - 12 (far right softkey)
- (d) Press the ENT key.
- (e) Select MAG INTERFERENCE TEST and press the ENT key.
- (f) Follow the checklist items displayed on the PFD, and press the ENT key as each one is completed or confirmed.
- (g) When the CALIBRATE field is blinking, press the ENT key to begin the procedure.

- (a) Start the PFD and MFD in Configuration Mode by holding ENT on each display while closing the circuit breaker.
- (b) Go to the GSU Page Group on the PFD by rotating the large FMS knob.
- (c) Select the GSU/GMU Calibration Page, as shown in "Figure 37" on page 342502128. This page is protected and requires a keystroke password to perform this test. Press the following softkeys in sequence:
  - 9
  - 10
  - 11
  - 12 (far right softkey)
- (d) Press the ENT key.
- (e) Select MAG INTERFERENCE TEST and press the ENT key.
- (f) Follow the checklist items displayed on the PFD, and press the ENT key as each one is completed or confirmed.

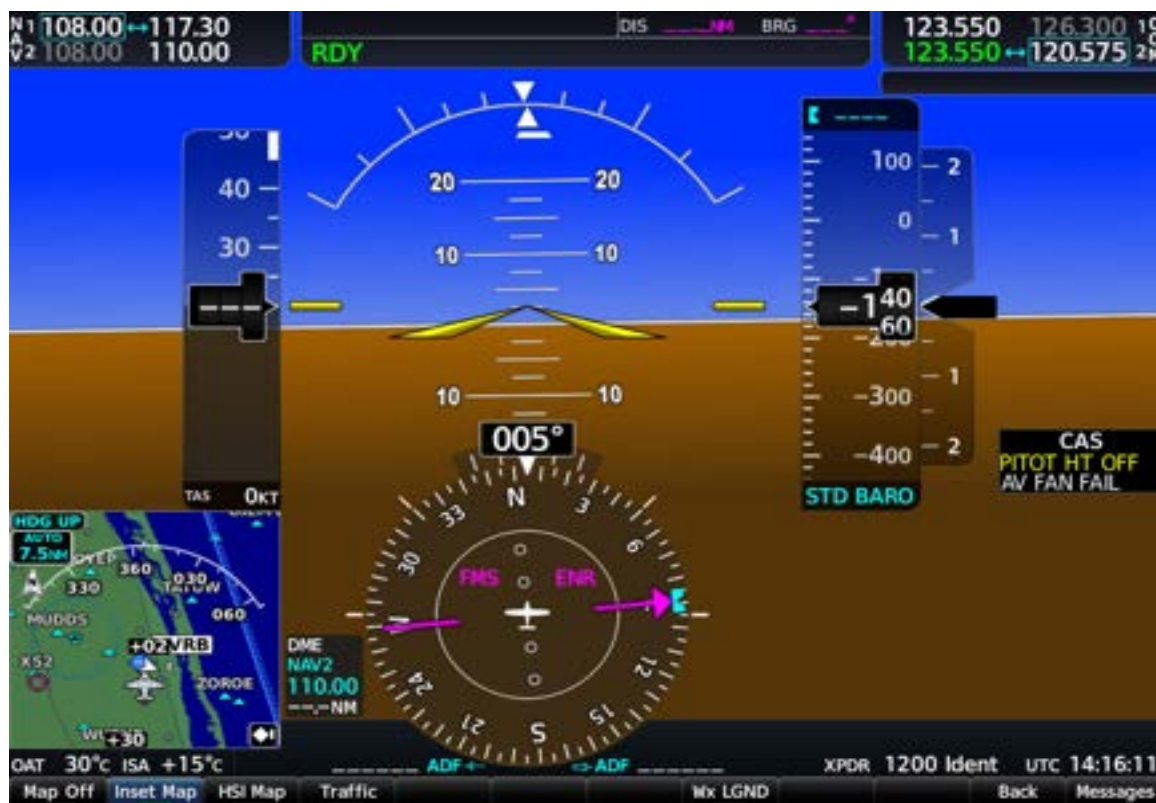
ADAHRS Normal Mode Check  
Figure 38

The aircraft may now be taxied back and the engine can be shut down for final testing. Restart the displays in Normal Mode to conduct final system checks. When the PFD powers up in Normal Mode, the ADAHRS attitude and heading information displayed should become valid within one (1) minute of power-up, as shown in "Figure 38" (provided both GPS receivers have a valid position; if GPS is unavailable, ADAHRS initialization may take as long as two (2) minutes).

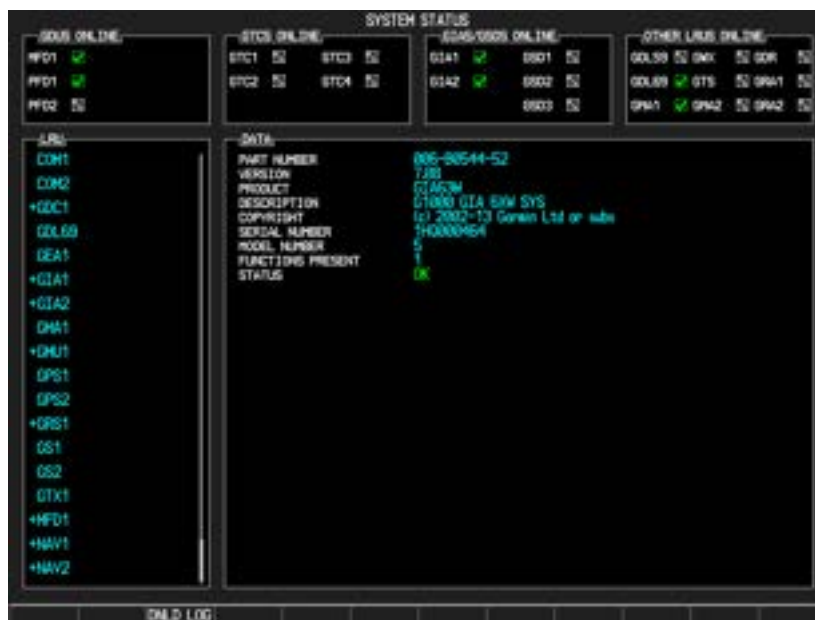
System Status Page (Configuration Mode)  
Figure 40

- (a) The PFD System Status page (see "Figure 40" on page 342503137) displays a list of LRUs in the LRU window.
- (b) Enter Configuration Mode on the PFD and MFD by applying power while holding ENT.
- (c) Verify on the System Configuration Page that the following are valid (indicated by green annunciations): MFD, PFD, GIA1, GIA2, and GDL 69A / 69eA (optional).
- (d) Verify on the System Status Page that the following are valid (green annunciations indicate that the system is healthy): MFD, PFD, GIA1, GIA2, and GDL 69A / 69eA (optional).
